# NORTHRIDGE EARTHQUAKE: LIFELINE PERFORMANCE AND POST-EARTHQUAKE RESPONSE

Technical Council on  
Lifeline Earthquake Engineering,  
American Society of Civil Engineers

Edited by Anshel J. Schiff

April 1997

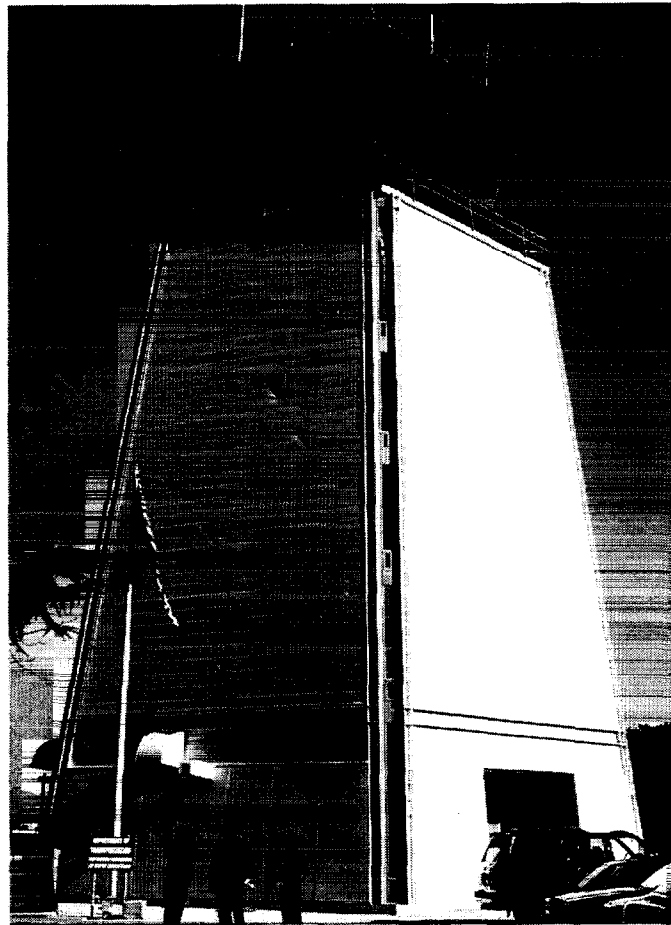
Figure 10.2 shows an overview of the control tower and cab. The gashes in the tower siding were caused by the window as it fell, suggesting that they came out as a unit or fractured and large pieces fell to the ground. A fragment of the window is shown in Fig. 10.3. Each of the five sides of the cab has two window panes separated

Fig. 10.2 Overview of the Van Nuys control tower with gashes in siding caused by windows falling from the cab.

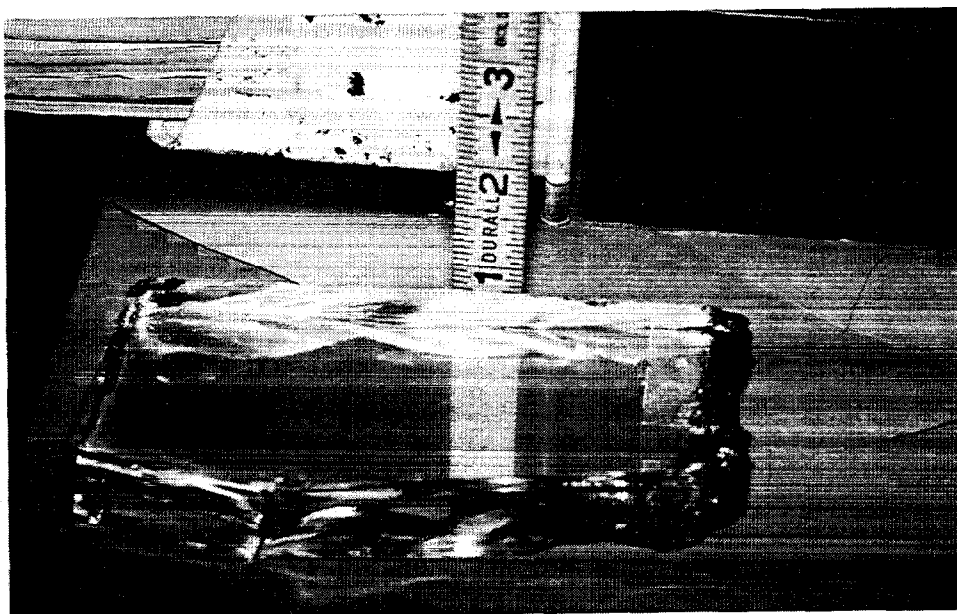
Fig. 10.3 Fragment of control tower window glass that is  $\frac{3}{4}$ " (2 cm) thick.

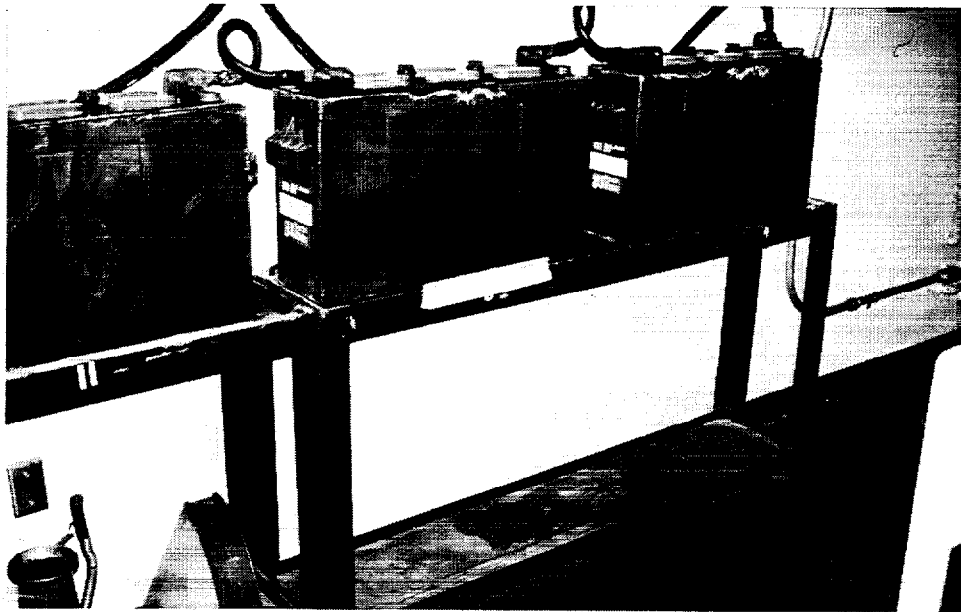
The control tower engine-generator was anchored at the time of the visit, but was unanchored at the time of the earthquake. The batteries used to start the engine-generator were not secured to their battery rack and the rack was not anchored, Fig. 10.5. The utility transformer that supplied power to the control tower is located adjacent to the tower was unanchored, but did not move during the earthquake. The control tower is normally closed during the early morning hours. A uninterruptable power supply in the base of a cabinet was unanchored, but continued to operate, Fig. 10.6. Air handling equipment in the tower was on vibration isolators that were unanchored and appeared to have moved as much as 4" (10 cm) as a result of the earthquake, Fig. 10.7.

Fig. 10.5 Batteries used to start the emergency engine-generator are unsecured to their rack and the rack is not anchored.

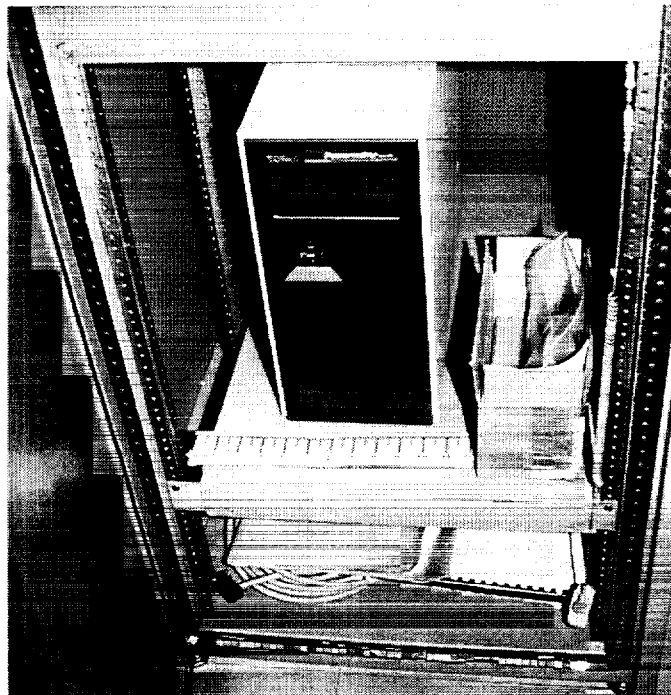
Fig. 10.6 A uninterruptible power supply in the bottom of a cabinet was unanchored. It did not move and continued to operate after the earthquake.

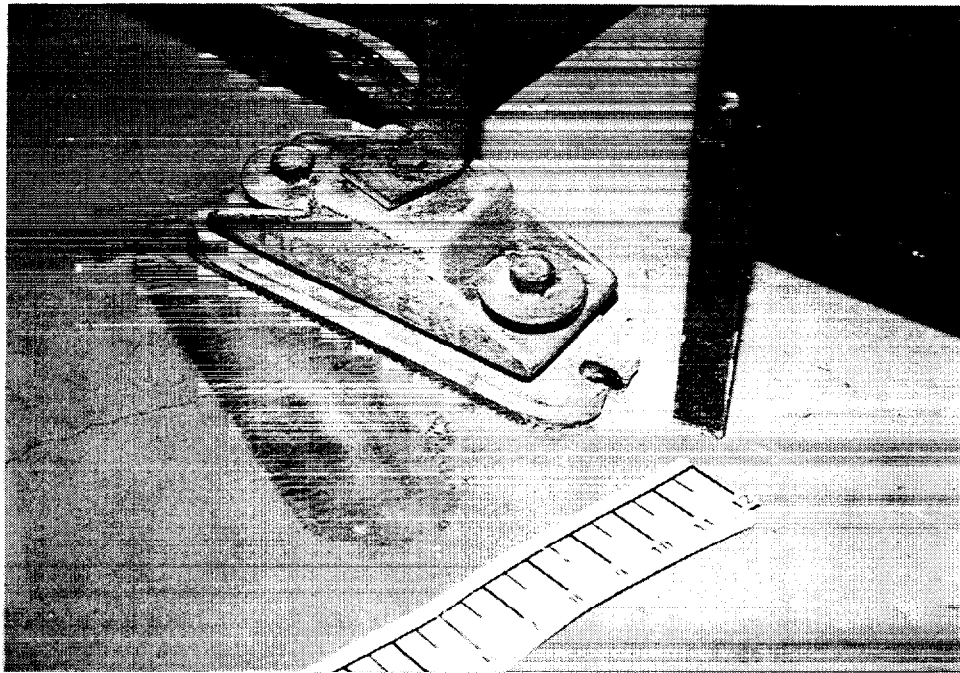
Fig. 10.7 Vibration isolation pad used to support air handling equipment was unanchored and moved about 4' (10 cm).

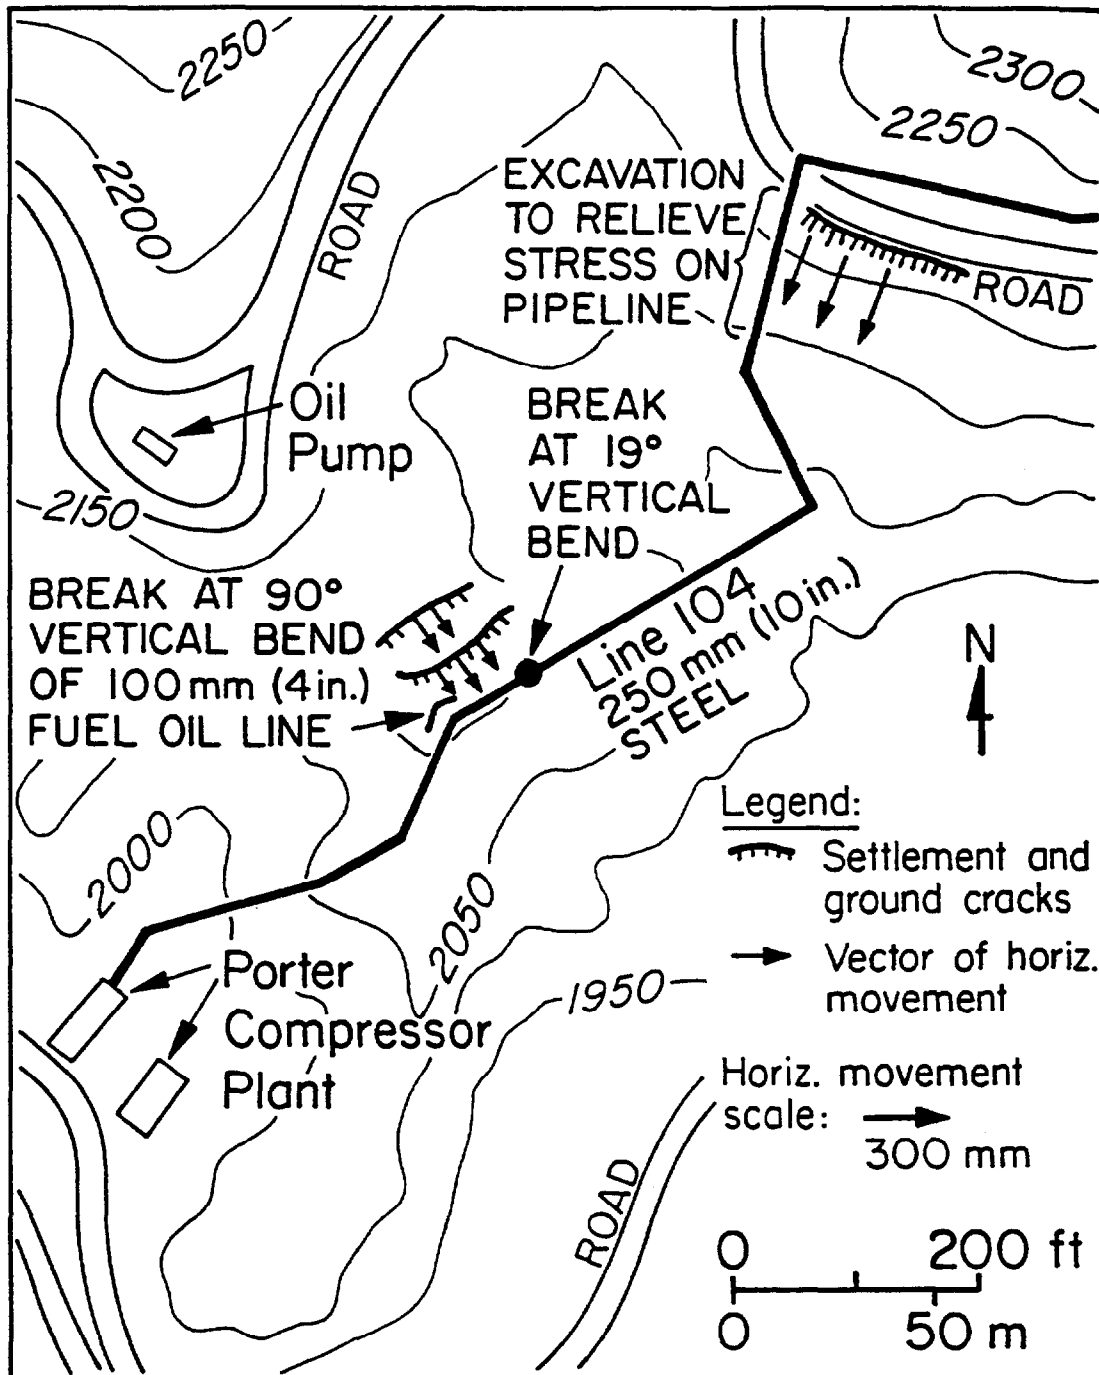
Fig. 12-3. Plan view of Line 104 in the Aliso Canyon Gas Storage Field.

Figure 12-3 shows a plan view of Line 104 in Aliso Canyon relative to the site topography. The rock in the area covered by the figures is highly fractured, friable siltstone and sandstone with 0.6 to 3 m (2 to 10 ft) of silty sand cover in many places. Pipe damage appears to be related to slope displacement perpendicular to the pipeline, which also caused an adjacent 100-mm- (4-in.)-diameter, steel fuel oil line to fail at an aboveground vertical bend. Slope displacement adjacent to the access road in the northeast part of the figure threatened Line 104, and the pipeline was excavated in the slope area to free it from the adjacent soil.

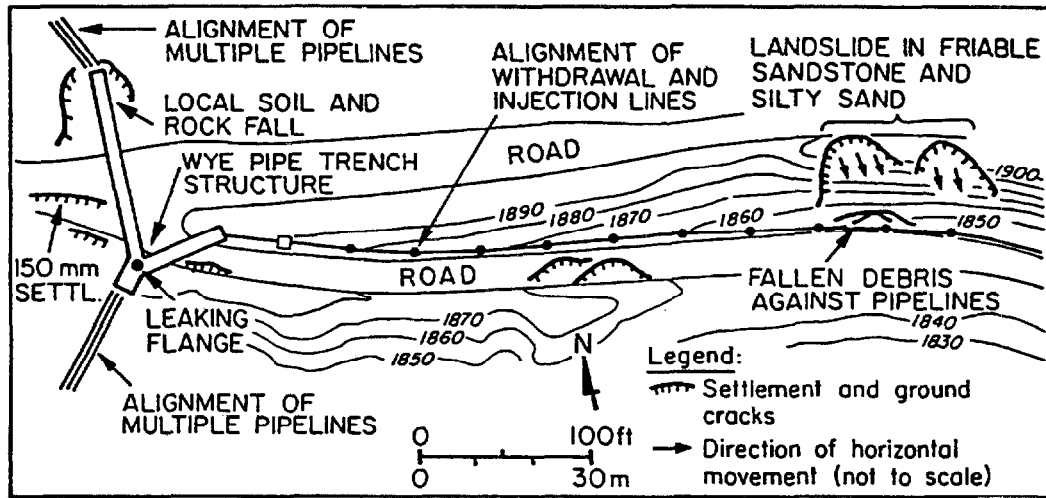
Figure 12-4 shows a plan view of surficial ground movement and gas facilities near the location of a leaking flange in Aliso Canyon. Downslope movement at the Wye structure caused deformation at the flange of a withdrawal pipeline, thereby breaking the seal at the gasket. Local soil and rock failure exposed the drilled shaft foundations of aboveground pipeline supports north of the Wye structure. Withdrawal and injection lines along the access road were deformed by fallen debris in the landslide area at the eastern side of the figure.

Fig. 12-4. Plan view of Wye pipe trench structure and aboveground pipelines influenced by local landslide activity at Aliso Canyon Gas Storage Field.

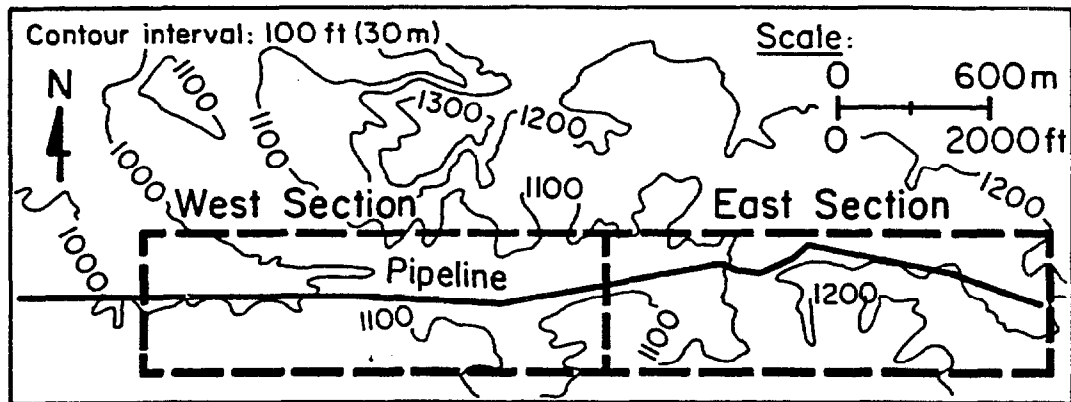
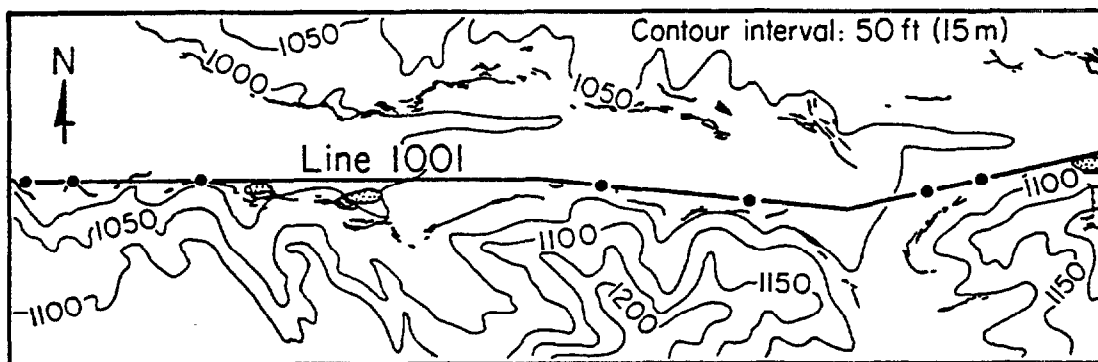
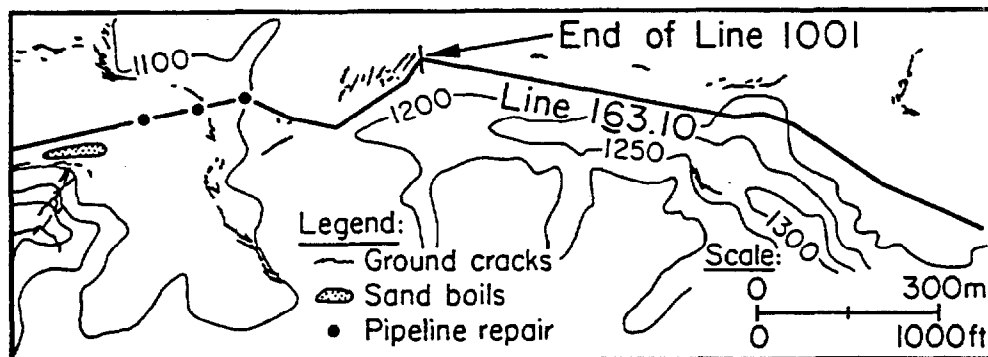
Figure 12-5 shows the location of Line 1001 in Potrero Canyon in relation to ground deformation features and sand boil locations mapped by Rymer, et al. (1995). Ten locations of pipeline repair are shown in the figure, all of which were separations and cracks at oxy-acetylene welds. Approximately half the locations of pipeline repair coincide with mapped ground cracks.

Fig. 12-5. Map of locations of pipeline repair and ground deformation features in Potrero Canyon. [Based on map prepared by Rymer, et al. 1995.]

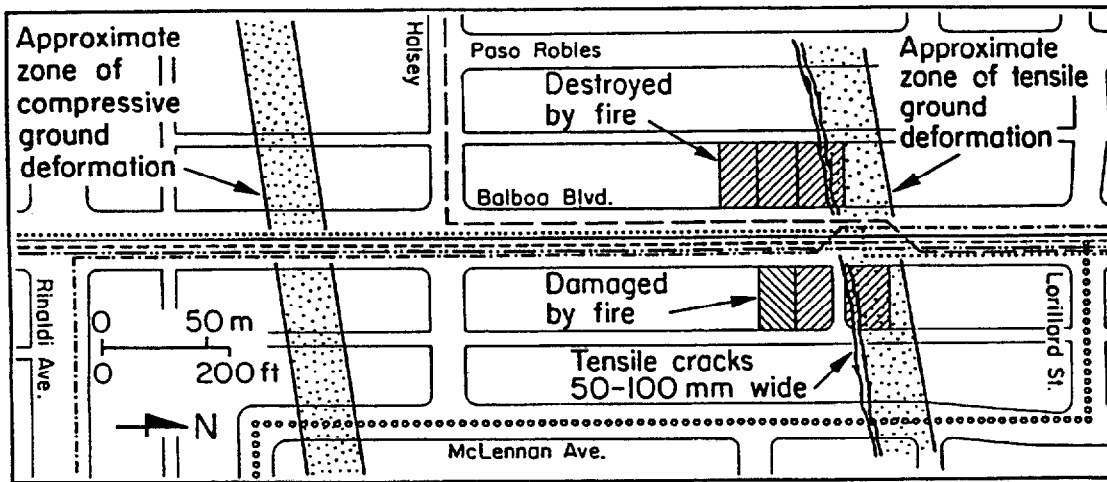
Figures 12-6 and 12-7 show maps of the pipelines in Balboa Blvd. near the zones of permanent ground deformation. There were six transmission and water trunk lines at this site. There were two 750-mm- (30-in.)-diameter gas transmission lines with 9.5-mm-(0.375-in.)-thick wall, constructed of X-52 steel in the 1950s which were not damaged. There was a 400-mm- (16-in.)-diameter petroleum pipeline, operated by the Mobil Oil Corporation, which was not damaged. The pipeline was composed of X-52 steel and installed in 1991. Two water trunk lines, the 1,240-mm- (49-in.)-diameter Granada and the 1,730-mm- (68-in.)-diameter Rinaldi Trunk Lines, failed in tension and compression in the tensile and compressive zones of ground deformation, respectively.

Fig. 12-6. Map of major pipelines, fire damage, and ground deformation on Balboa Boulevard.

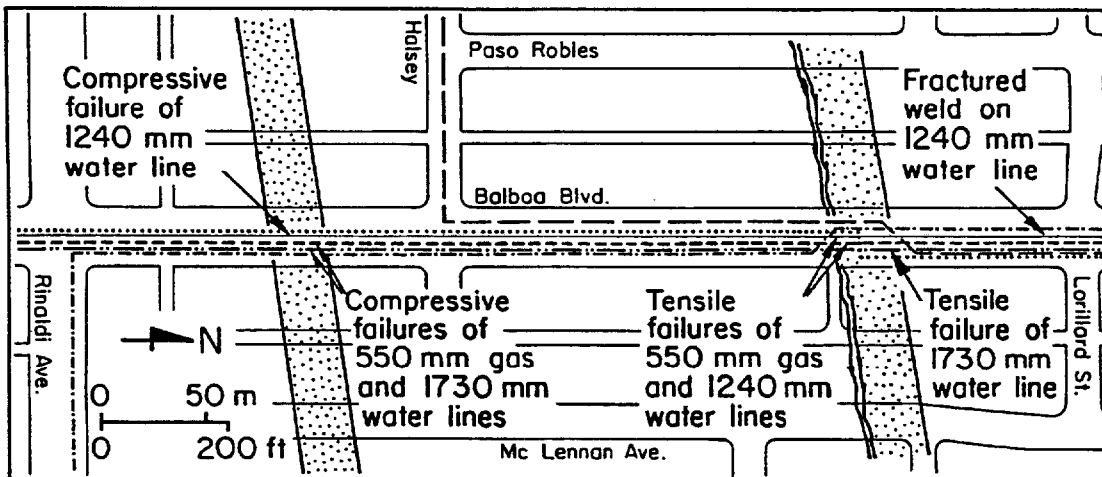
Gas pipeline damage on Balboa Blvd. occurred in Line 120, a 550-mm- (22-in.)-diameter steel pipeline constructed in 1930 with unshielded electric arc girth welds. At the time of the earthquake, the line was operated at about 1.2 MPa (175 psi). The pipe had a wall thickness of 7.2 mm (0.281 in.) and was composed of Grade B steel. The pipeline failed in tension in a zone of tensile ground deformation about 300 m (900 ft) north of a zone of compressive ground deformation where the pipe failed by compressive wrinkling.

Fig. 12-7. Map of major pipelines, ground deformation zones, and locations of pipeline damage on Balboa Boulevard.

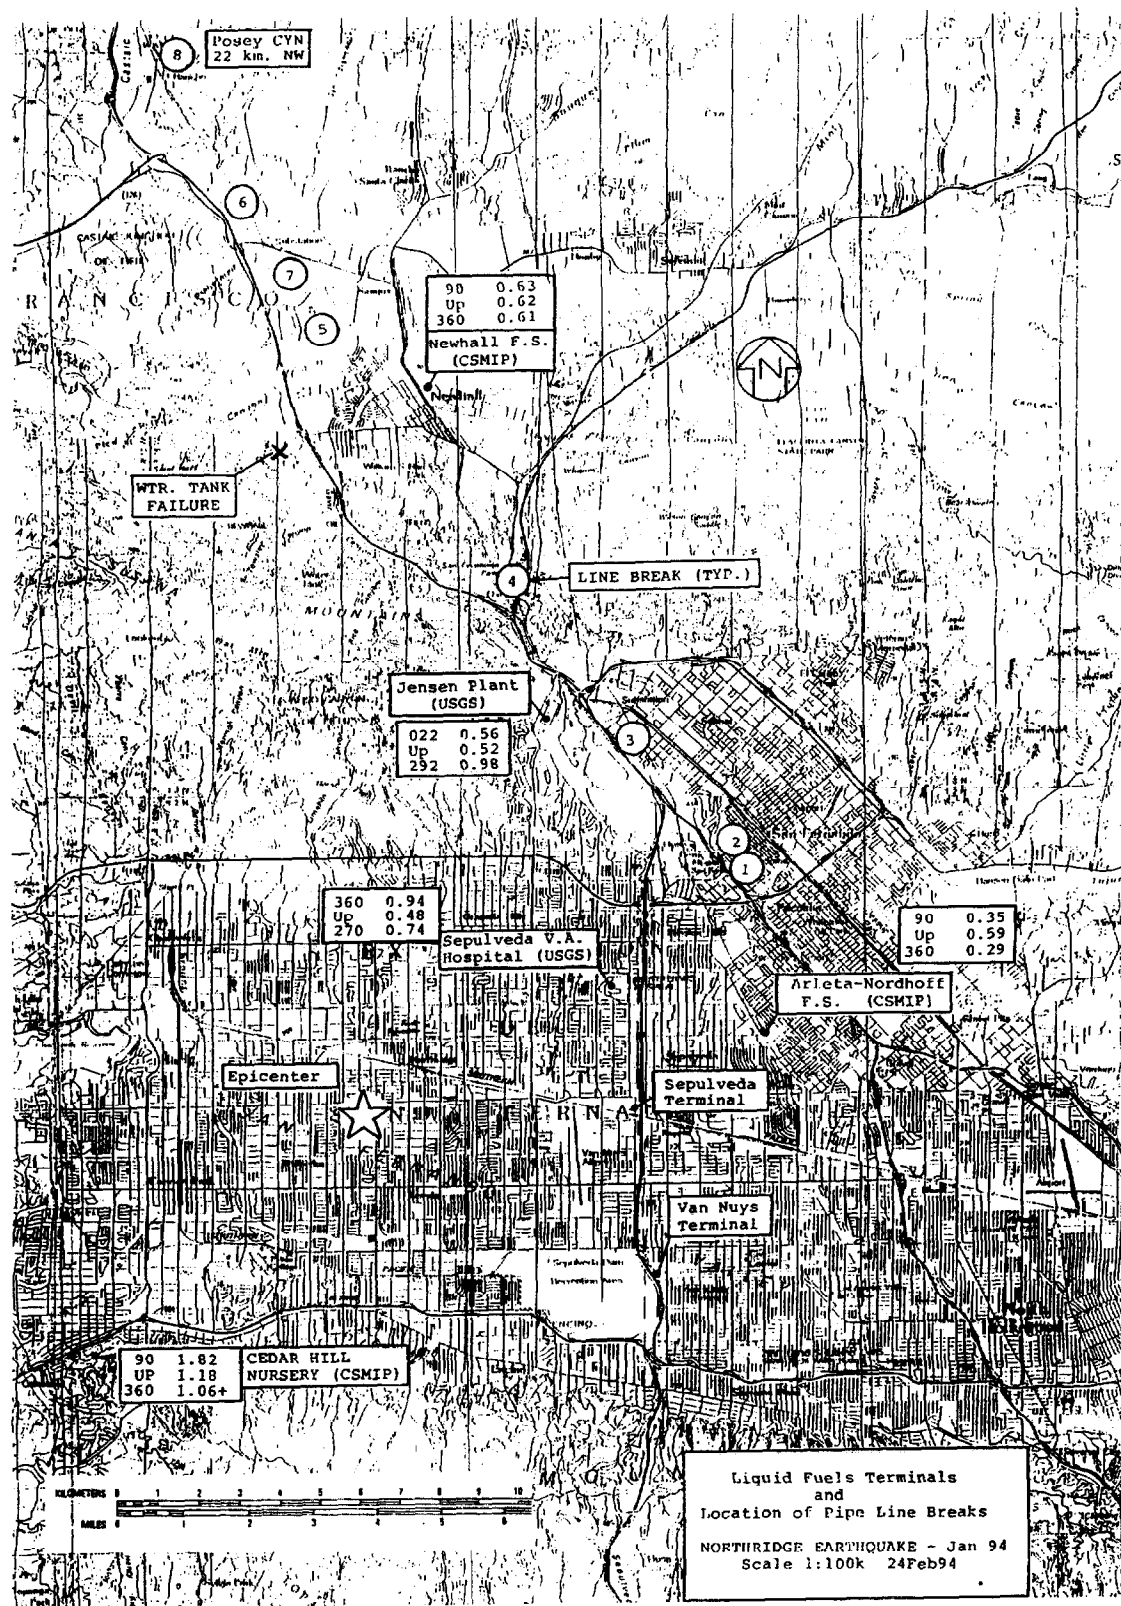
Figure 13.1 shows the general area, the location of the two terminals, and the significant pipeline breaks.

Fig. 13.1 Liquid fuel terminals and pipeline break locations.

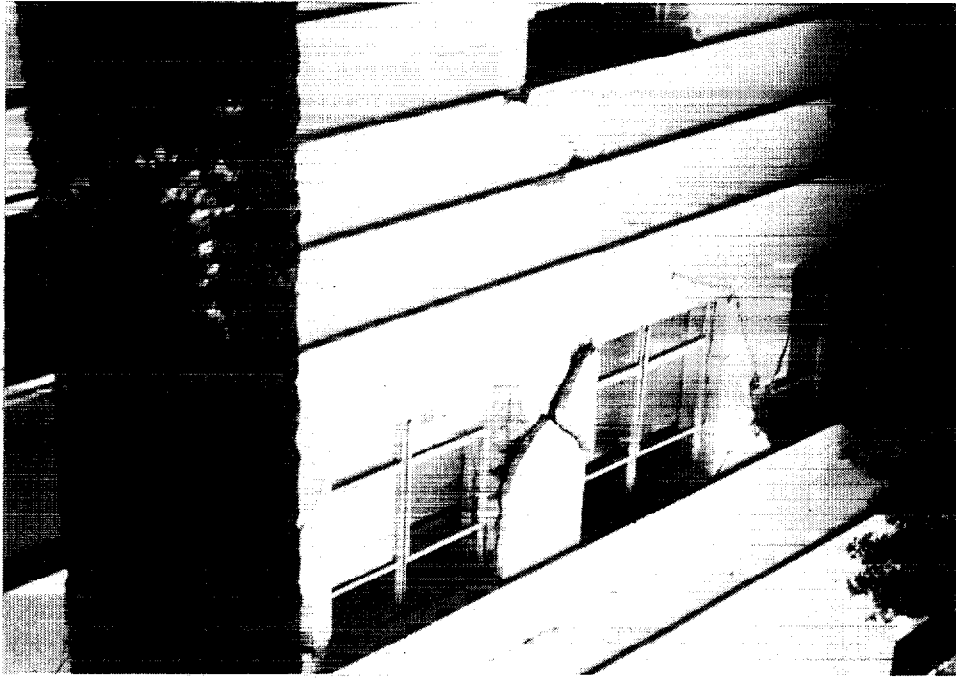
The red tagged north wing was a non-ductile reinforced concrete frame built in 1954. This wing, which is long in the east-west direction, had a soft second story. Significant structural damage occurred in this wing. This included shear cracks in the exterior window pier columns, and interior beam, floor and column damage, Fig. 15.1.

Figure 15.1. St. John's Hospital. Shear cracks in columns of soft story of north wing.

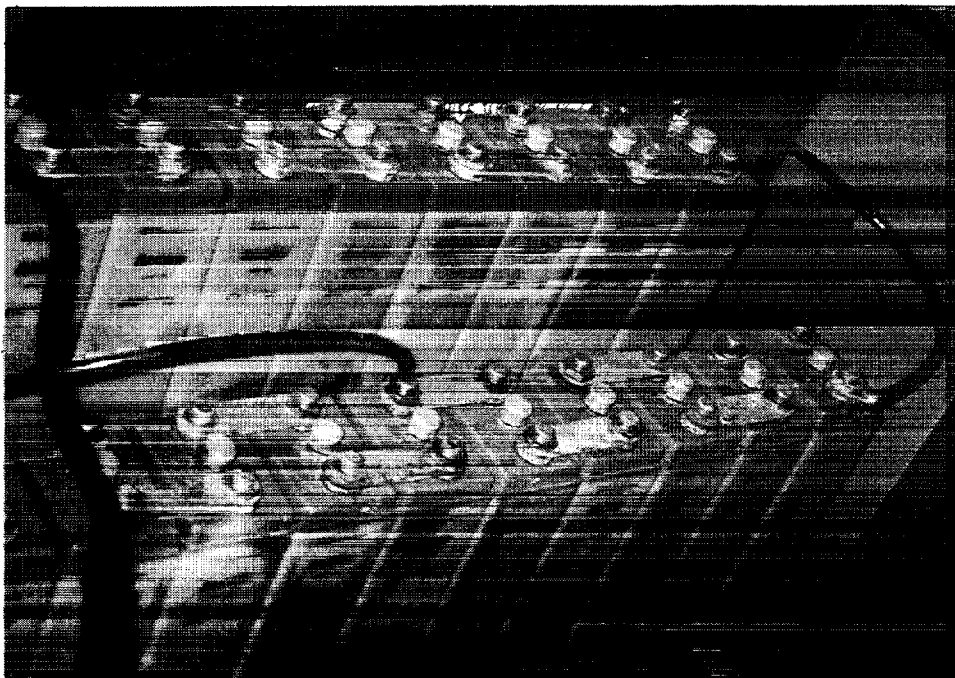
The facility lost commercial electrical power for a period of about 12-14 hours. During the earthquake, many of the batteries which are used to start the emergency generators toppled over and snapped their cables. The batteries were not restrained in their racks, Fig. 15.2. However, personnel were able to start up all six generators. All generators are shock mounted and their cooling water systems had no leaks, Fig. 15.3. The generators operated properly until numerous electrical grounds occurred as a result of interior water leaks in the facility. (These leaks occurred when interior nonload bearing partition walls were damaged by the pounding of the various wings of Building #3 at their joints with the main body of the structure.) These electrical grounds caused almost all circuit breakers to trip open. Thus most functions in the entire facility were without any electrical power. This condition lasted for two days, until the grounds were repaired and the facility was energized one building at a time. Power was restored to all but two buildings by about 60 hours after the earthquake. However, Bldgs. #3 and #99, remained without electrical power for five days, because switchgear and transformers had been knocked off their supports. For example, one 750 KVA transformer sheared its 0.75 inch (2 cm) anchor bolts and the support pad underneath one 300 KVA transformer sank. In total, there was over \$1.5 million in electrical equipment damage.

Figure 15.2. VA Hospital. Emergency generator batteries, which were not restrained at top and bottom, toppled over.

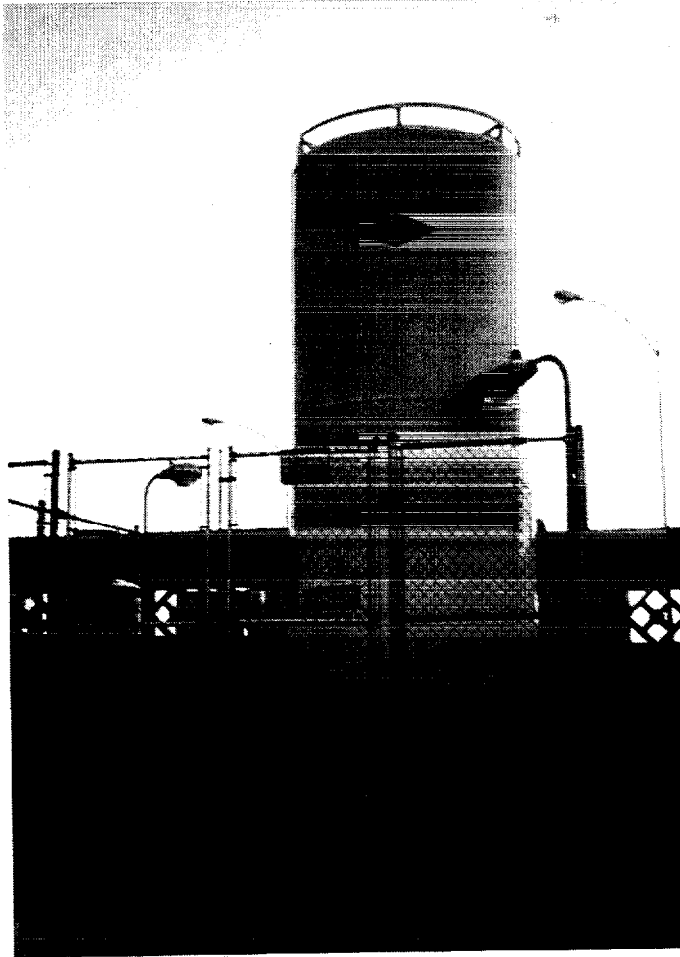
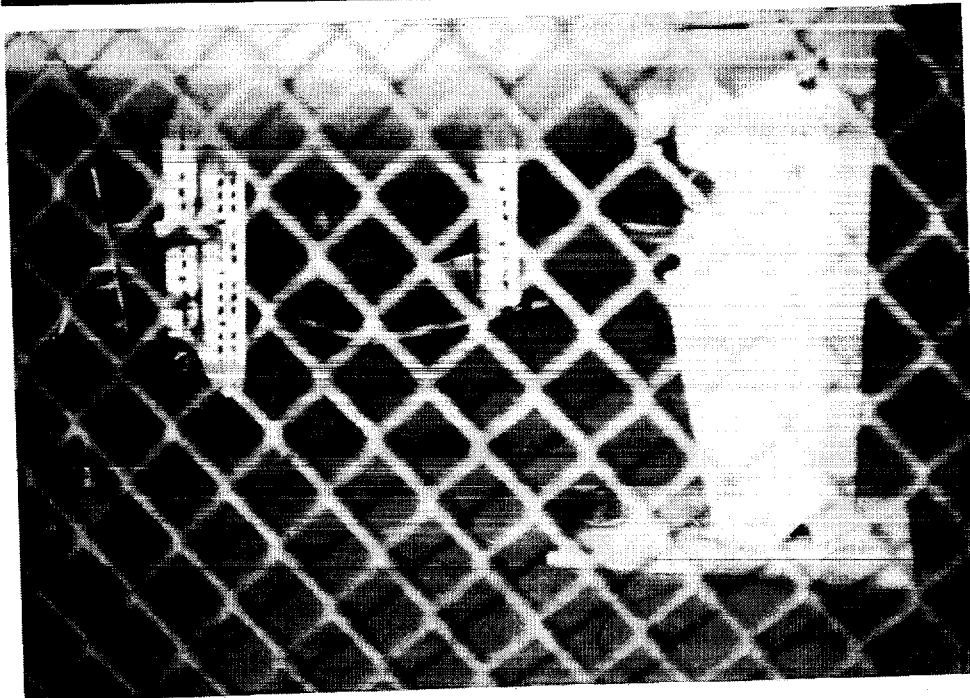
It was observed that medical gas cylinders were restrained by chains. But one set toppled over when the chain broke as a result of the earthquake. One large liquid oxygen tank, measuring about 8 feet (2.4 m) in diameter and about 15 feet (4.6 m) tall, and restrained by a single 1.0 inch (2.5 cm) diameter anchor bolt on each of its three legs, suffered no damage, Figs. 15.4 and 15.5.

Figure 15.4. VA Hospital.  
Liquid oxygen tank. (Left)

Figure 15.5. VA Hospital.  
Liquid oxygen tank was  
supported on three legs each  
restrained by a single 1 in.  
bolt. (Below)

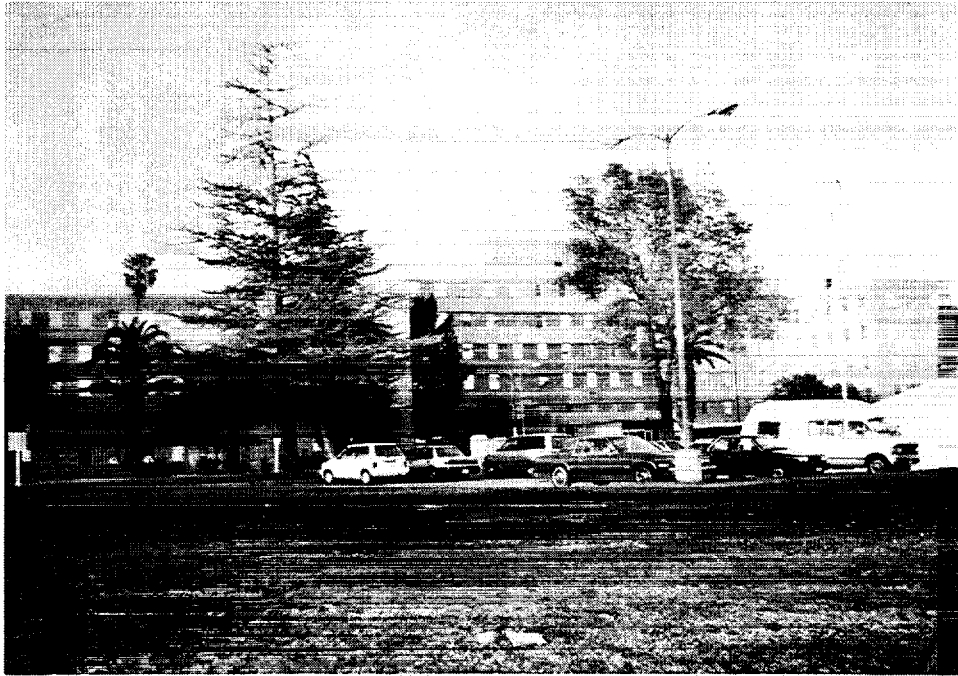
Building #3 suffered major damage and all patients in it were evacuated. It is a reinforced concrete frame structure with reinforced masonry infill walls. It has a main wing, which is six stories plus a penthouse, and several five story wings, Fig. 15.6. Seismic joints are located at the intersections of the wings with the main wing and with each other, Fig. 15.7. Significant pounding damage occurred at the joints between the southeast and east wings, between the west and southwest wings, and between the main wing and the southwest wing, Fig. 15.8. At these locations, the joints opened a larger amount in the upper stories and consequently the exterior pounding was worse in the upper stories. It was also observed that the interior lifeline damage was worse in the upper floors of the structure than at the first floor. For example, on the fifth floor, the cover plate over the seismic joint between the main wing and the southwest wing, buckled upward over 6 inches (15 cm). This would significantly impede the movement of patients on rolling stretchers. At this same location on the first floor, the plate moved horizontally less than 1 inch (2 cm).

Figure 15.6. VA Hospital. View of south side of building #3.

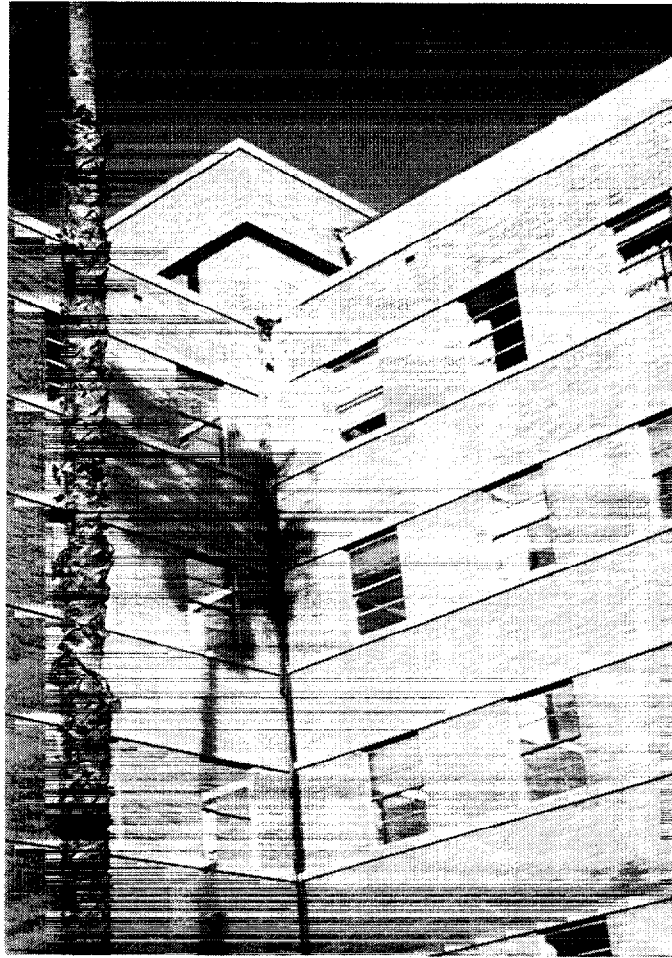
The pounding caused significant damage to the floor diaphragms and nonload bearing partition walls. The concrete cover on many floor joists was spalled off and the reinforcement bars were buckled. The fracture of brittle partition walls caused many leaks in the interior plumbing system. These leaks caused many electrical shorts and grounds, which caused circuits breakers to trip open and prevented the energizing of circuits when emergency electrical power was available.

Figure 15.8. VA Hospital. Bldg. #3. Pounding damage at seismic joint between southwest and west wings.

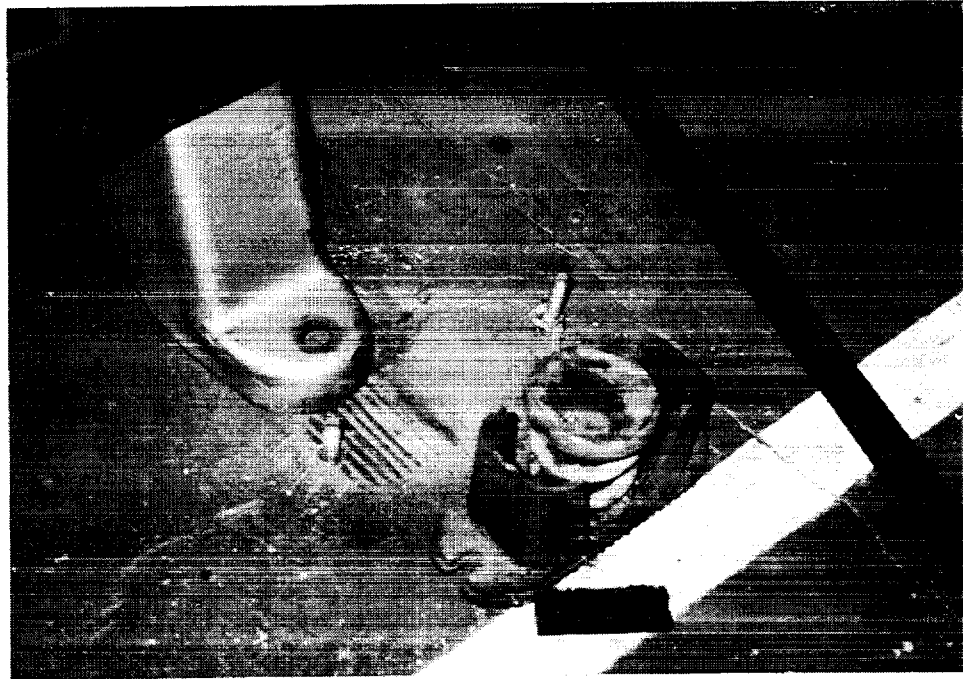
Building #40 contains the boiler plant and the chill water plant. In this building there was no damage to any chill water equipment since most equipment was bolted to the floor. However, the 12 inch (30 cm) chill water pipe out of the plant developed leaks at a flanged joint located about 8 feet (2.4 m) outside of the building. One horizontal air compressor tank jumped out of its spring-shoe supports, while an identical unit next to it did not move because it was solidly bolted to the floor, Figs. 15.9 and 15.10.

Figure 15.9. VA Hospital. Air compressor tank jumped out of this spring-shoe support.

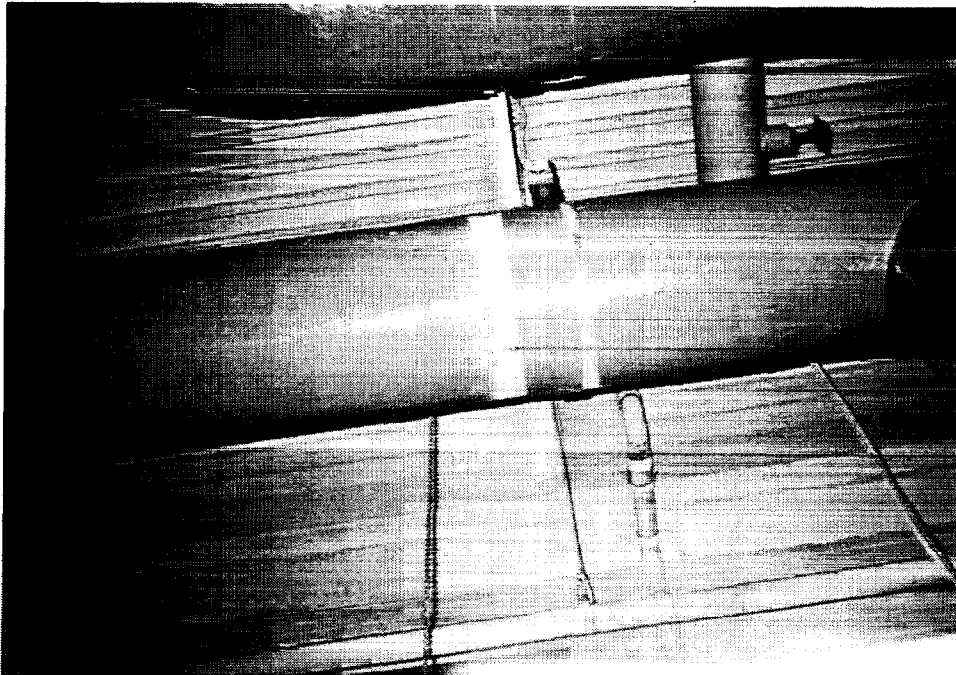
At several locations, it was observed that there was about 4 inches (10 cm) of relative axial displacement between pipe hangers and the supported chill water lines, Fig. 15.11.

Figure 15.11. VA Hospital. View looking upward of relative axial motion between chill water pipe and pipe hanger.

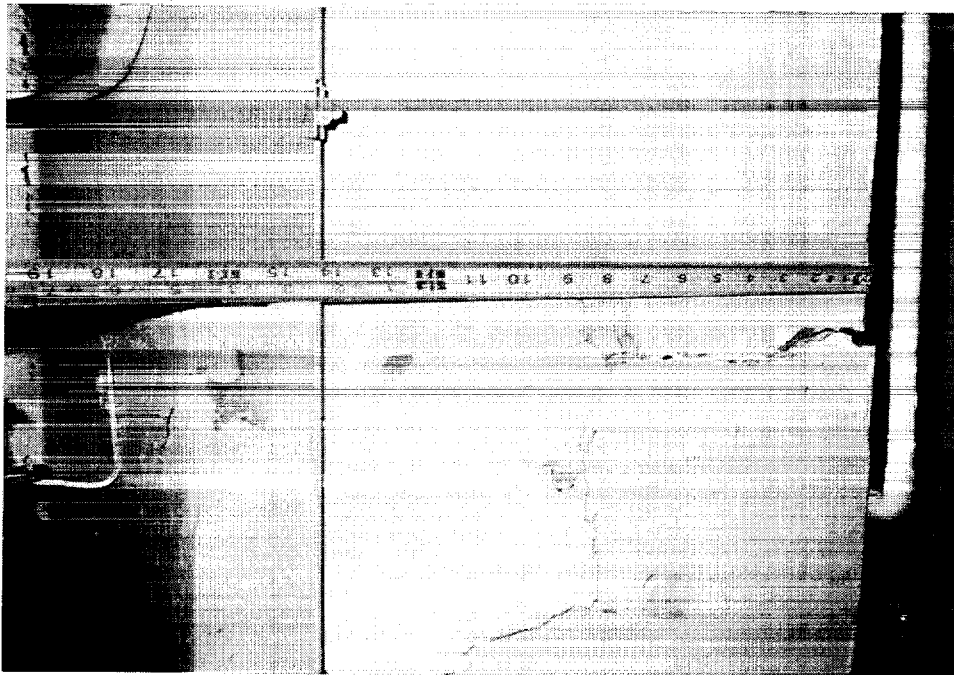
Figure 15.19. VA Hospital Bldg. #40. Interior column along north wall. Crack through entire cross section. (Below)

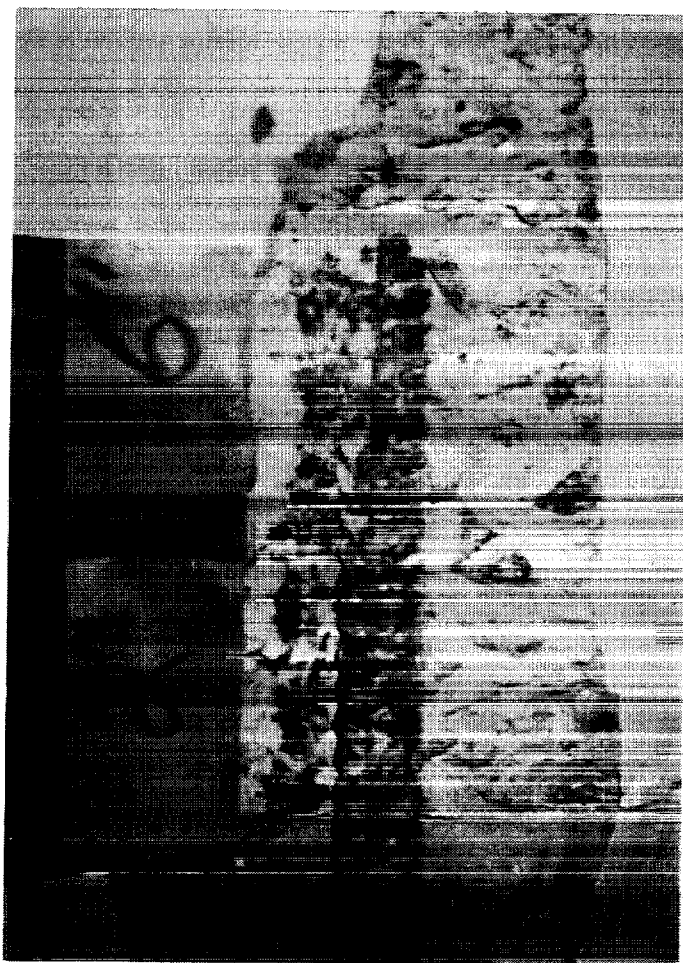
The portion of Building #40 containing the boiler plant was built in 1954 with a reinforced concrete frame and reinforced clay brick infill walls about 40 feet (12 m) high. The walls are double wythe, solid grouted, with #3 horizontal bars and #4 vertical bars. The part of the building containing the chill water plant was of more recent construction with solid grouted reinforced concrete masonry block walls about 20 feet (6 m) high. A seismic joint is at the intersection of the two parts. There were large diagonal shear cracks in the clay brick walls indicating that severe pounding occurred at this joint. The frame in the older part is stiffer along the west side than along the east side. See Figs. 15.14 and 15.15. Consequently, there was an eccentricity between the center of mass and center of stiffness of the building. Thus torsion occurred causing large cracks in the masonry at the northeast corner. See Figs. 15.16 and 15.17. At this corner, several bricks were knocked completely out of the wall so that the entire two wythes were exposed. See Fig. 15.18. Additionally, two 16x18 inch (40x46 cm) reinforced concrete columns along the north wall suffered cracks completely through their cross-section. See Fig. 15.19. On one of these columns, some concrete spalled off at a 6 inch (15 cm) lap splice, and the #7 reinforcement bars buckled, Figs. 15.20 and 15.21. There were no lateral ties observable in the columns.

Figure 15.20. VA Hospital Bldg. #40. Same interior column as Figure 15.19 along north wall. Concrete spalled at 6 inch lap splice.
